TECHNICAL NOTE

Contract NAS8-32982 **Date** 13 July 1979 **Doc.** LMSC-HREC TN D697613

Title: SPACE SHUTTLE SRB TPS PROTECTIVE PAINT TEST AND EVALUATION
IN NASA HOT GAS FACILITY AND AEDC TUNNEL C

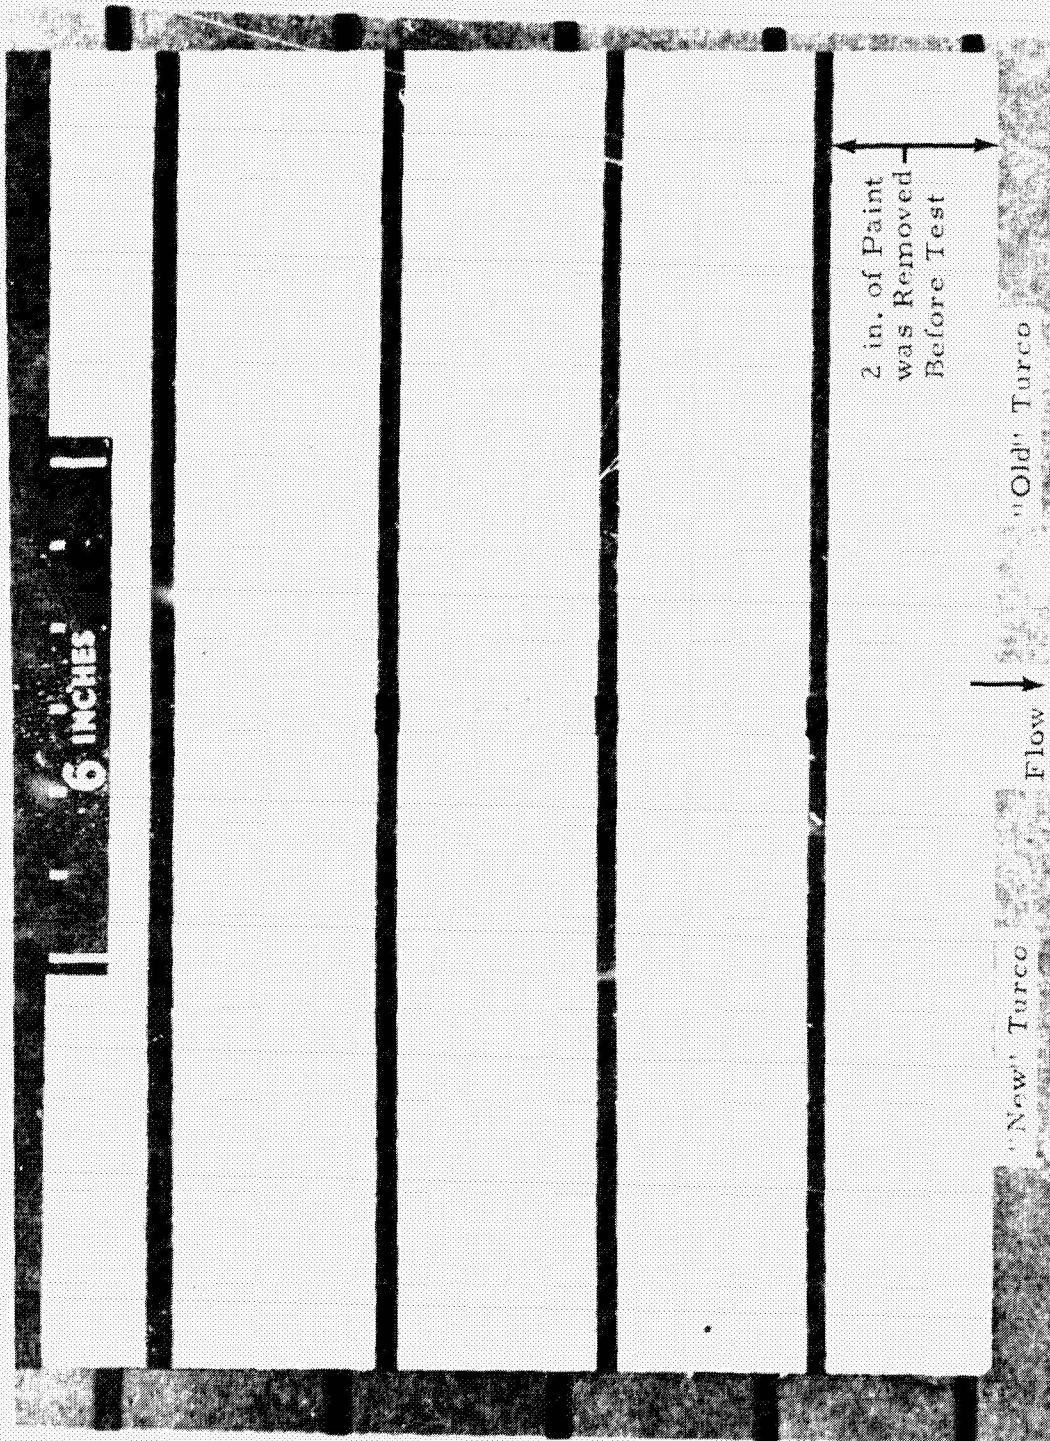
Fig. 4a - Pretest Photograph of Paint with Two Types of Turco Paint on B-Stage
Cork (Panel BVP-15)

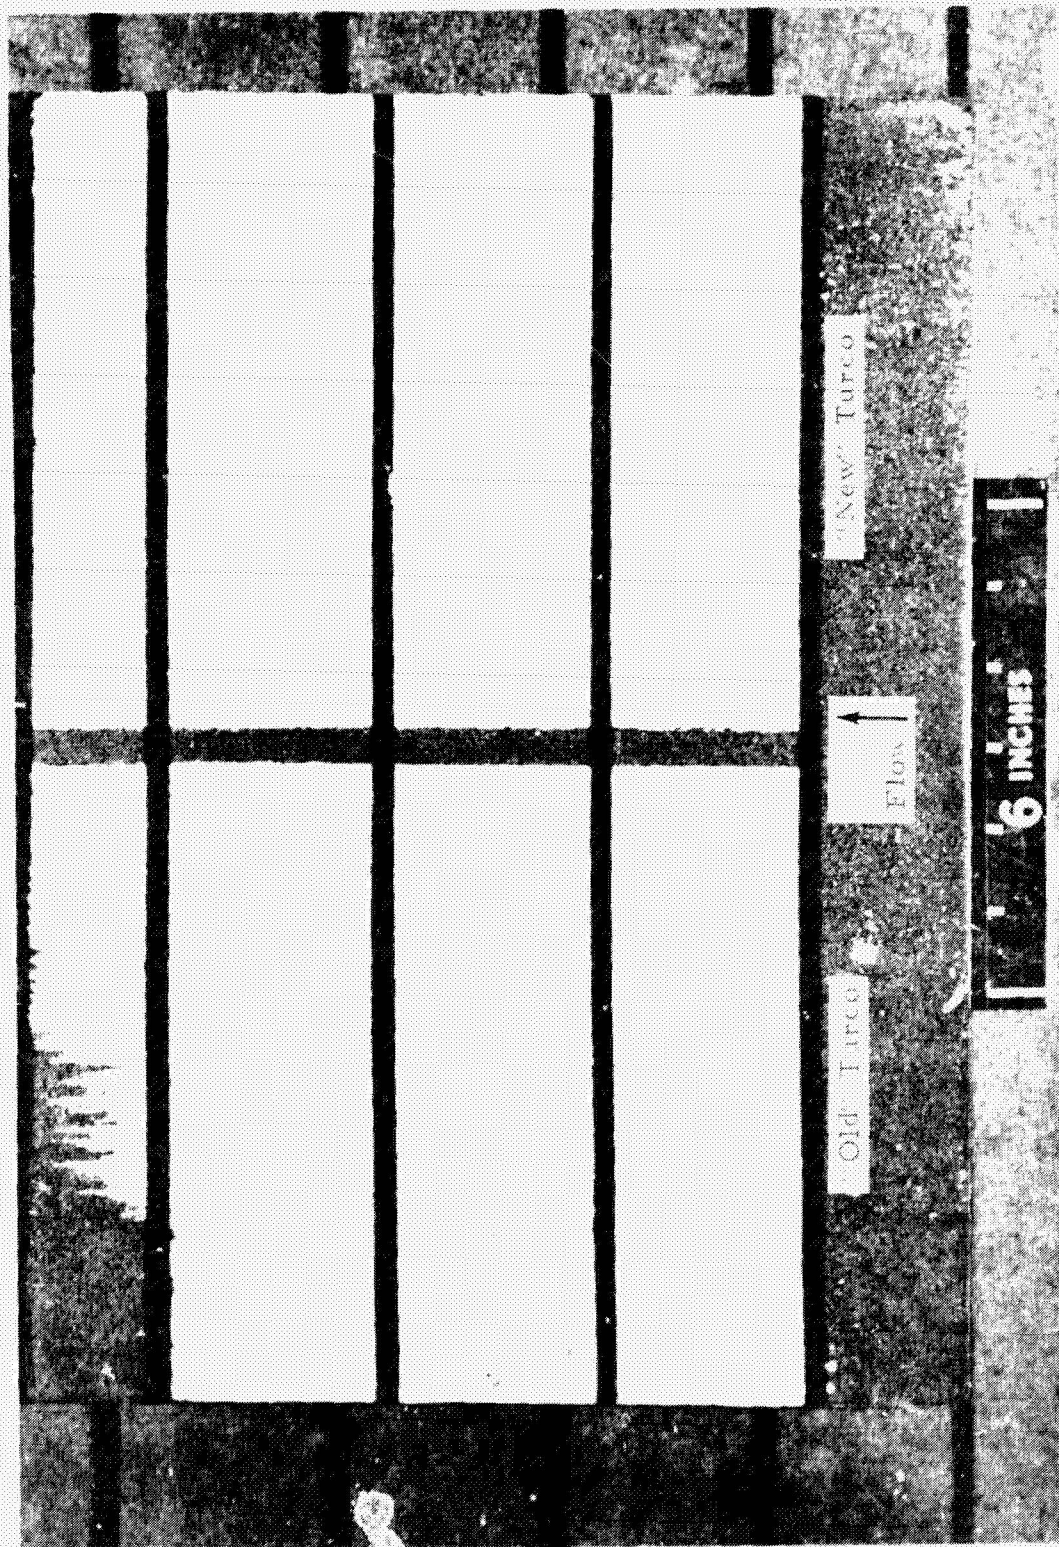
- The "old" as well as the "new" Turco paint both flowed about the same time although the "new" flowed first and was followed by the "old."
- An overcoat of "old" Turco on top of the "new" did not prevent nor retard any flow of paint.
- The Hypalon paint stayed on well. It formed small bubbles but did not flow during the entire heat load trajectory.
- All the new coatings, namely, the Woolsey, X3-5103, FL77, exterior latex and also Hypalon when used to overcoat the "new" Turco performed very poorly. They either flowed, bubbled up or disintegrated exposing the "new" Turco underneath which subsequently flowed. The coatings were not successful in even retarding the problem of paint flow.
- There was no effect of the type of TPS material whether MSA, P-50 cork or B-Stage cork on the performance of the paint. The behavior of the paint was independent from the type of TPS under it.

Fig. 4b - Post-Test Photograph Showing the "New" Turco Having Completed Its Run
Down the Panel Ahead of the "Old" Turco

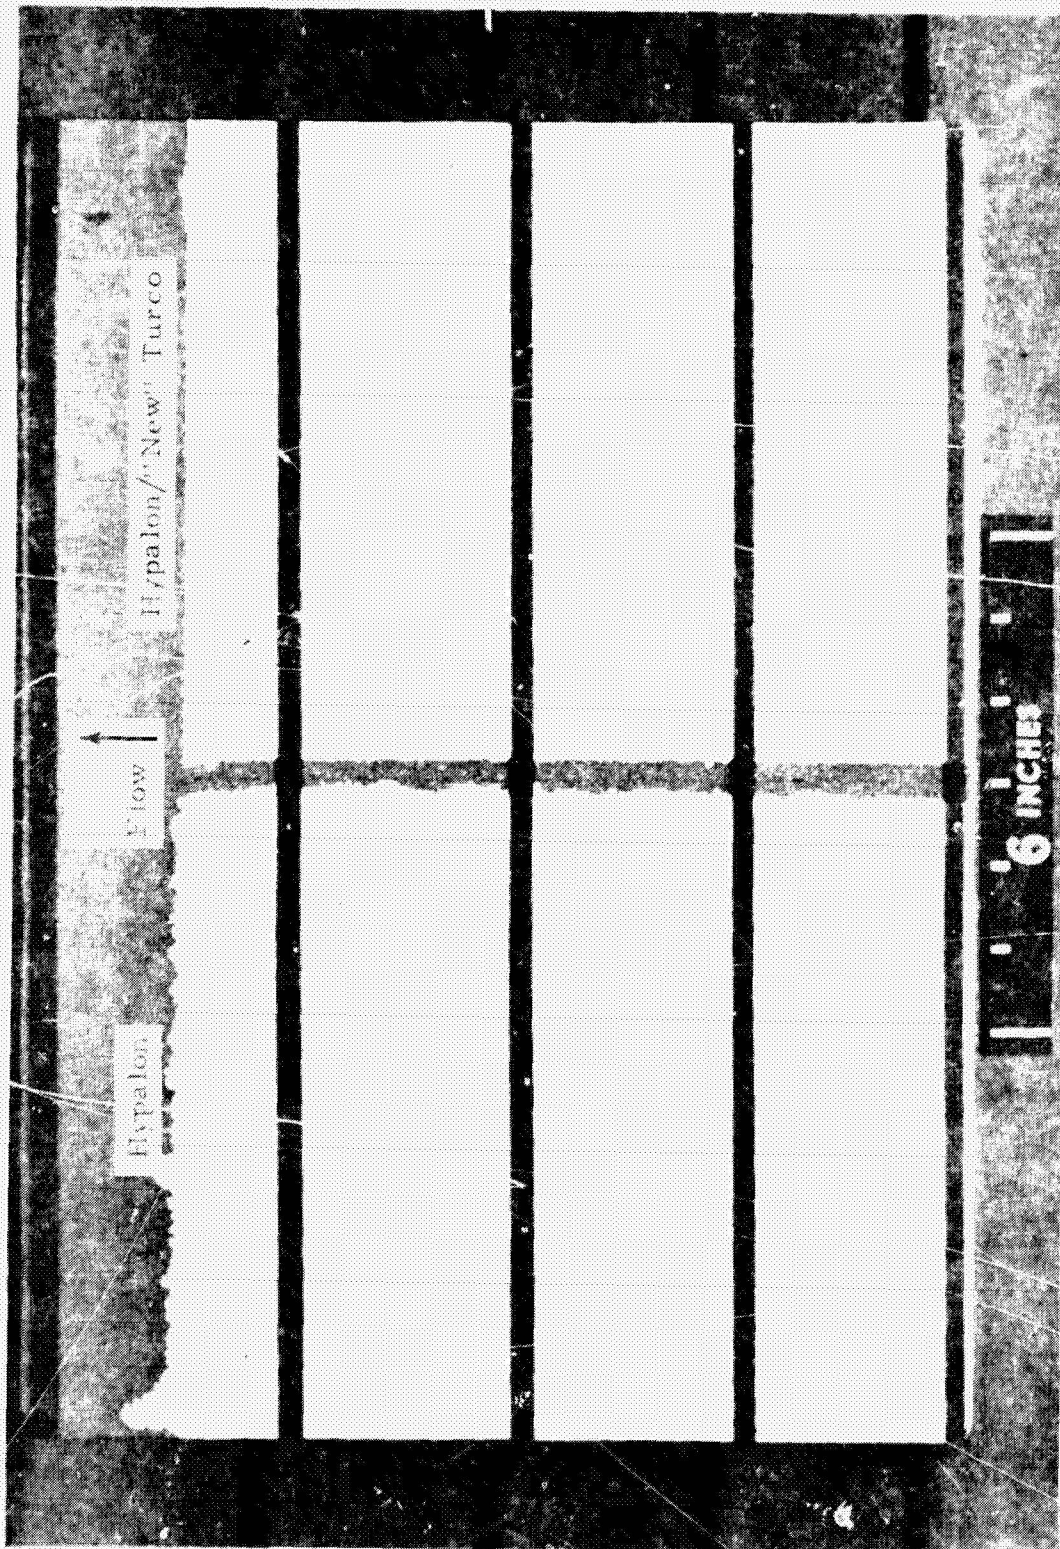
Fig. 5a - Pretest Photograph of Paint Panel with Hypalon Paint Applied over "New Turco" on One Side (Panel C-3)

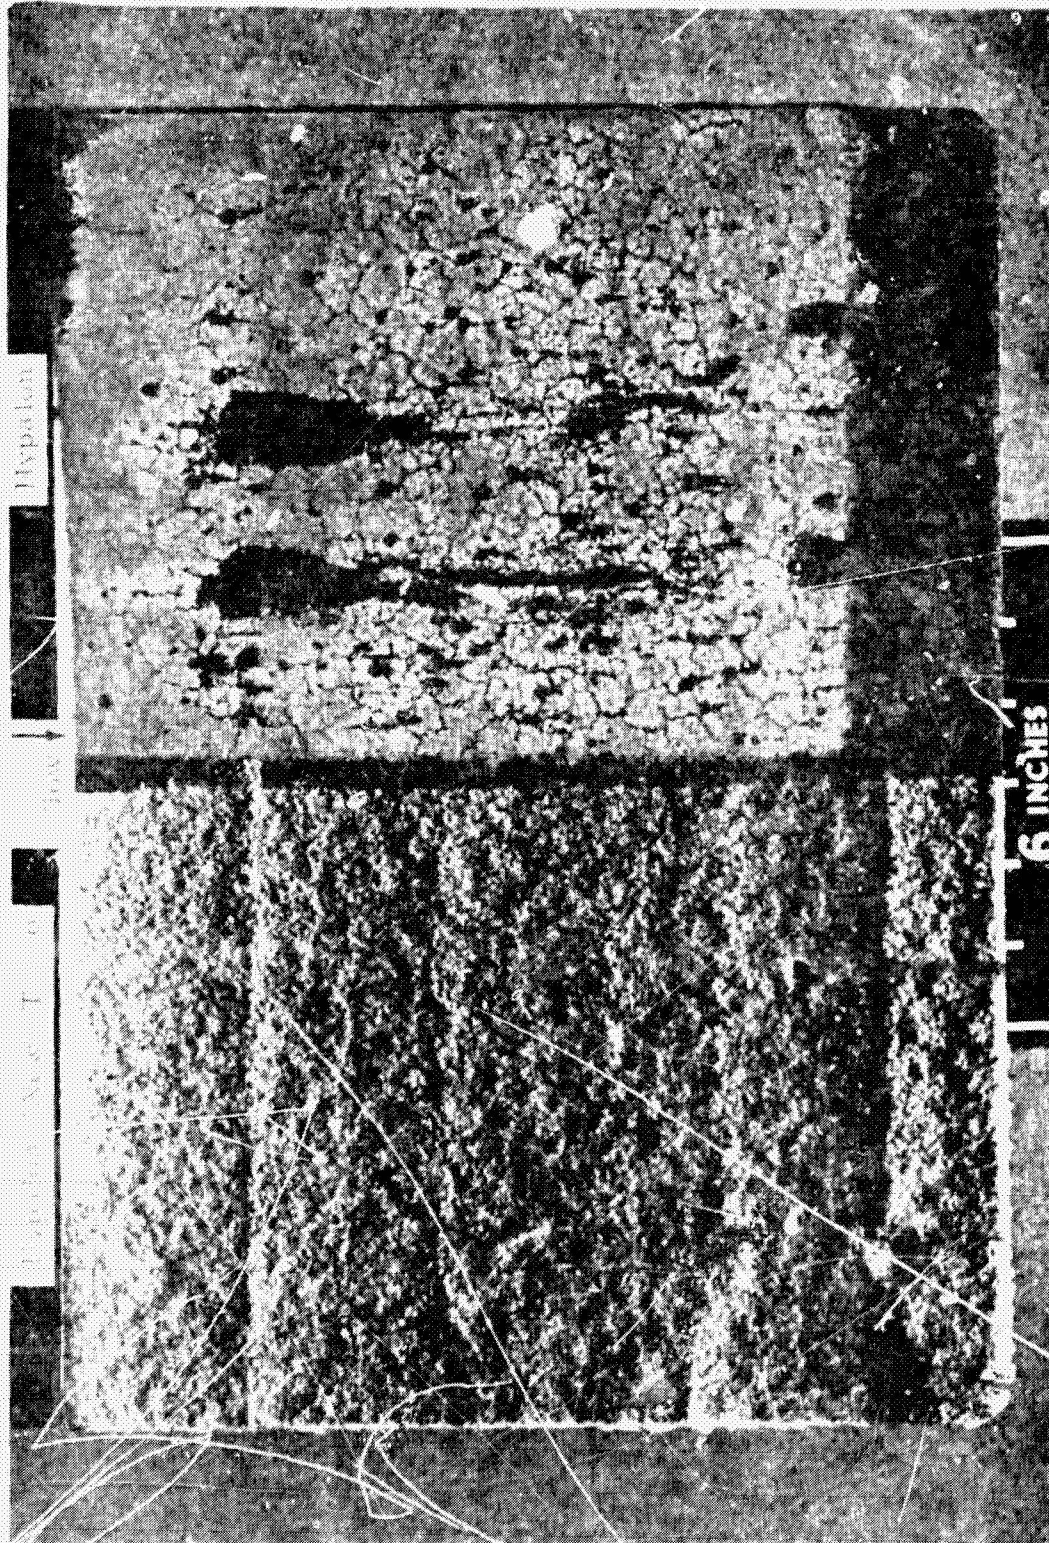
It was found that all the coatings, except the Hypalon, had similar undesirable flow characteristics. Also even the Hypalon, which did not flow, would bubble up and disintegrate when it was applied on top of the "new" Turco.

Fig. 5b - Post-Test Photograph. Showing the Hypalon by Itself, though "Cracked" Up and Having "Popcorned," Has Not Flowed Whereas when Coated over "New" Turco Has Not Prevented the Problem of Faint Flow

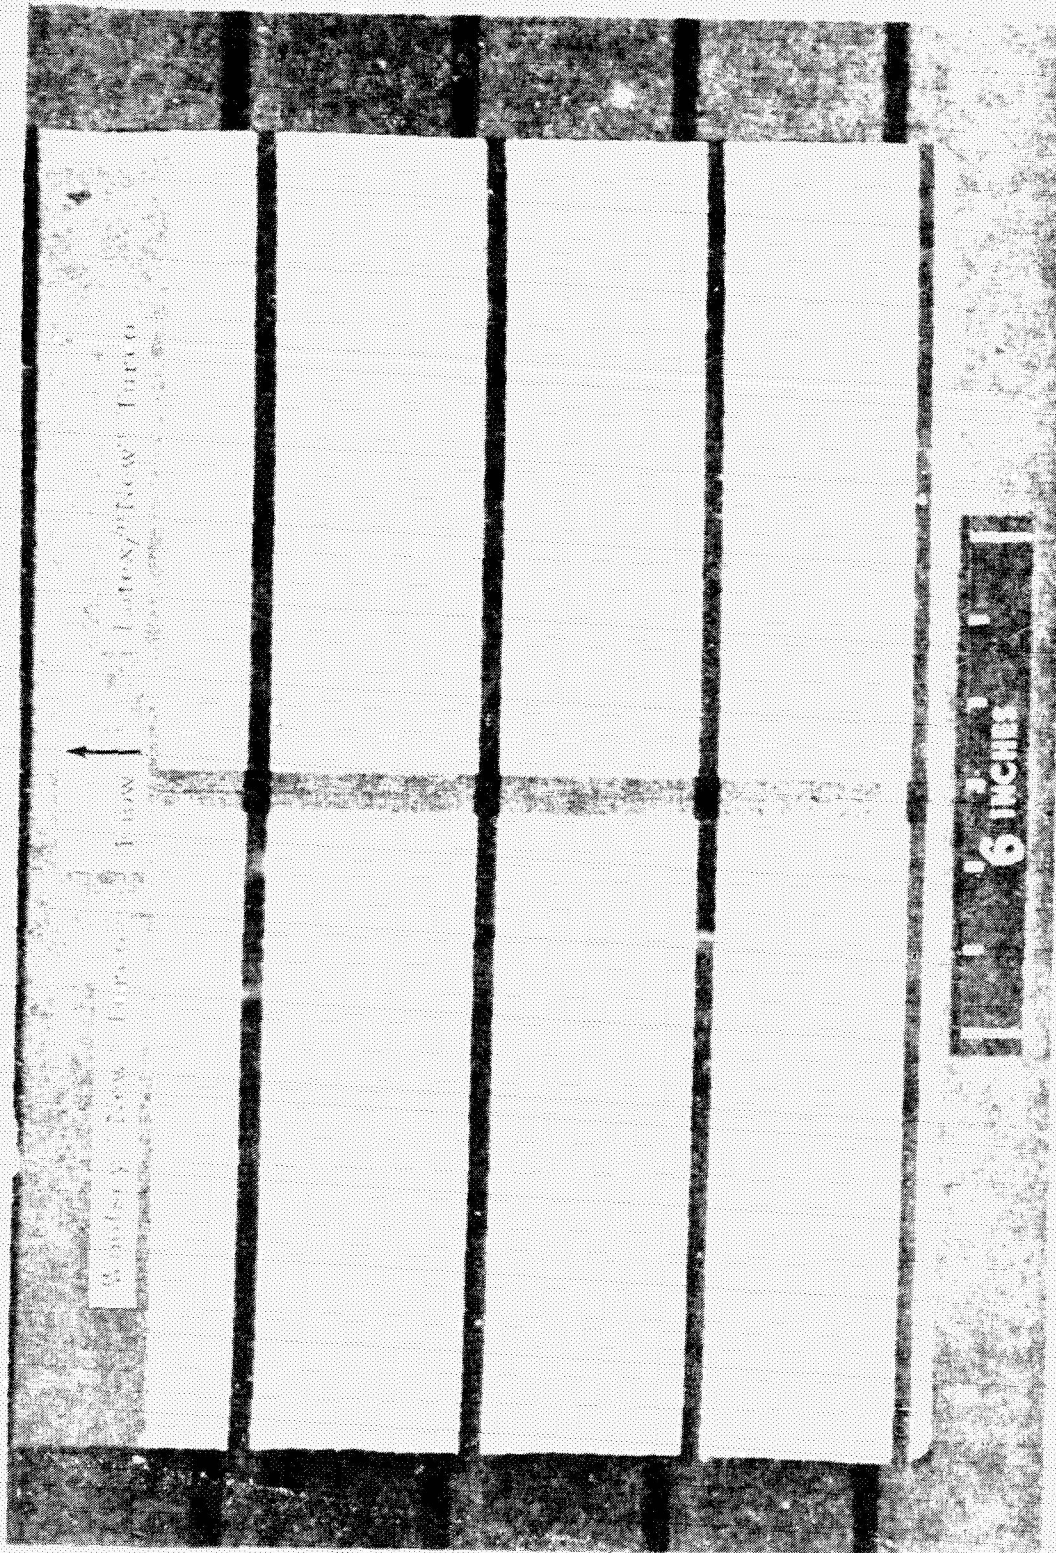
Fig. 6a - Pretest Photograph of Two Paints Coated over "New" Turco on P-50 Cork
TPS (Panel C-7)

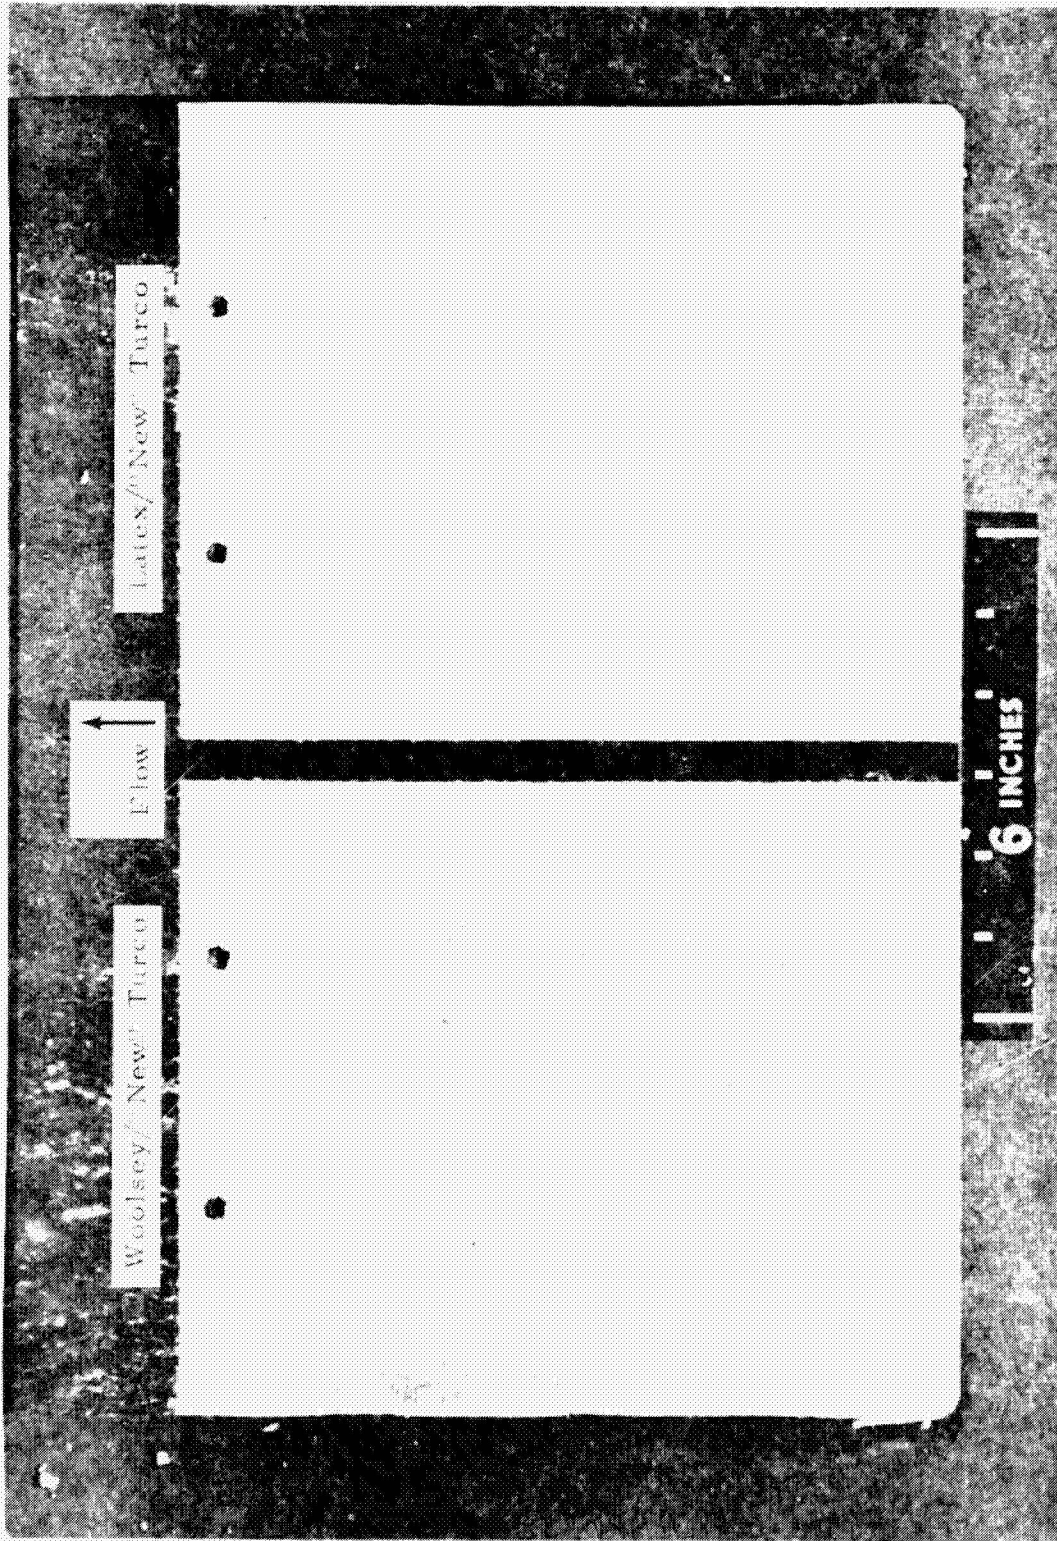
Fig. 6b - Post-Test Photograph Showing the Woolsey Coating Having Disintegrated Causing Paint Debris. (The Panel Was Run for Only 73.6 sec. If Run Longer the "New" Turco Would Have Run.)

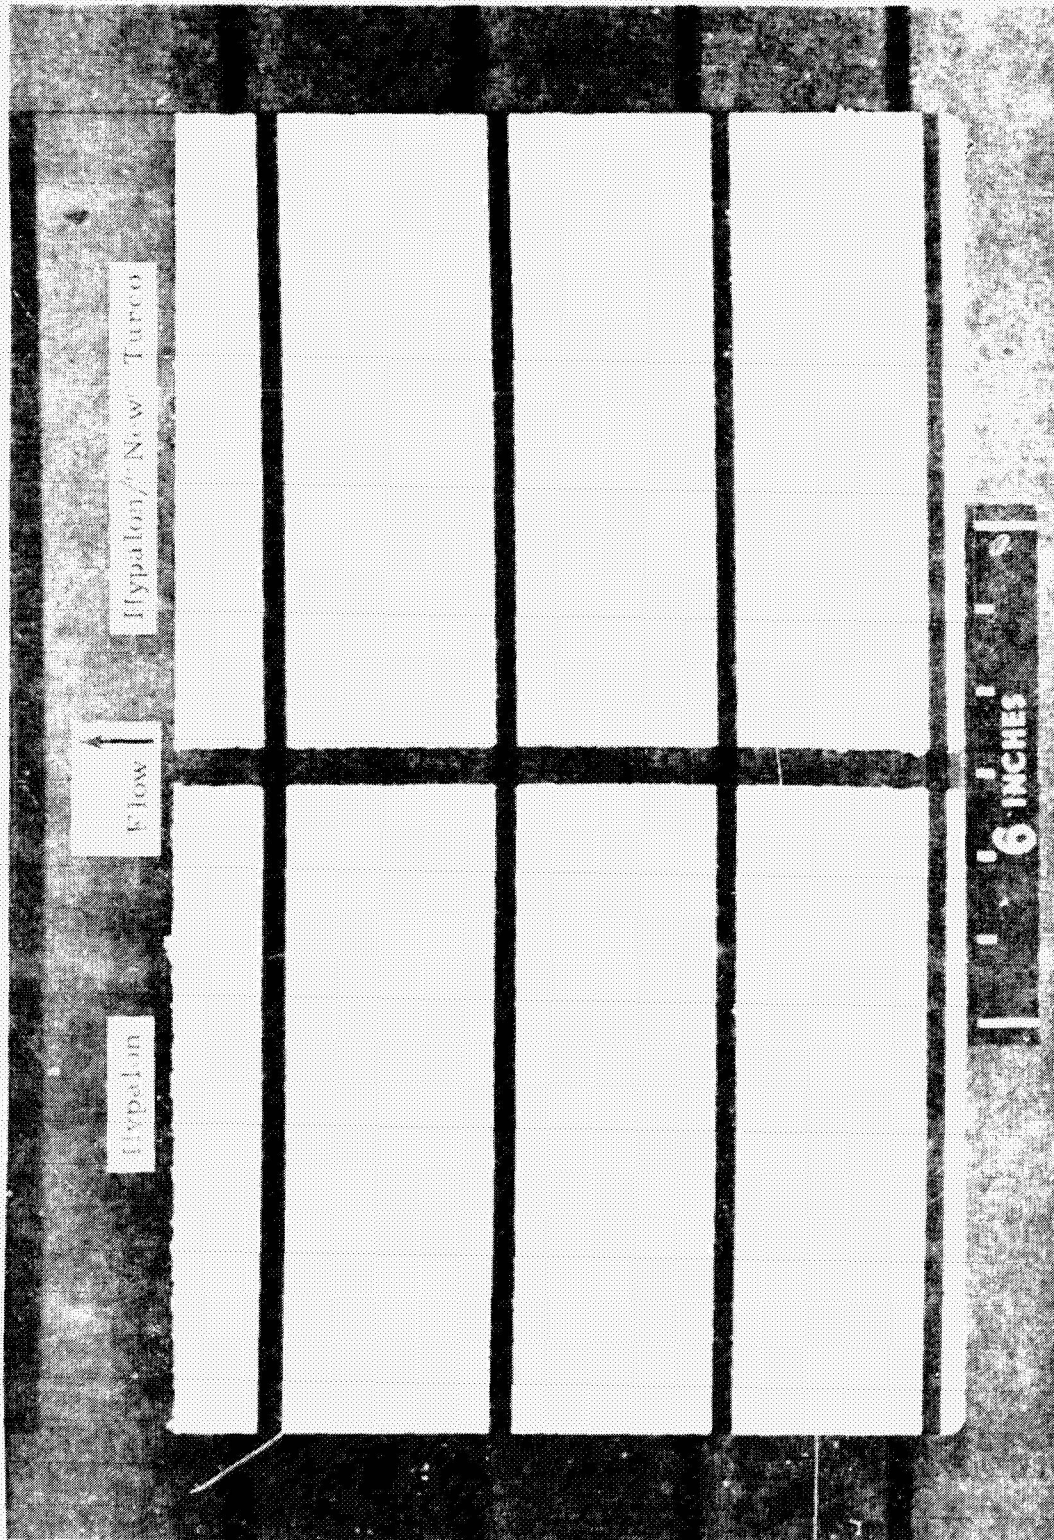
Fig. 7a - Pretest Photograph of Hypalon Paint and an Overcoat of the Same on "New" Turco
on MSA TPS (Panel M-2)

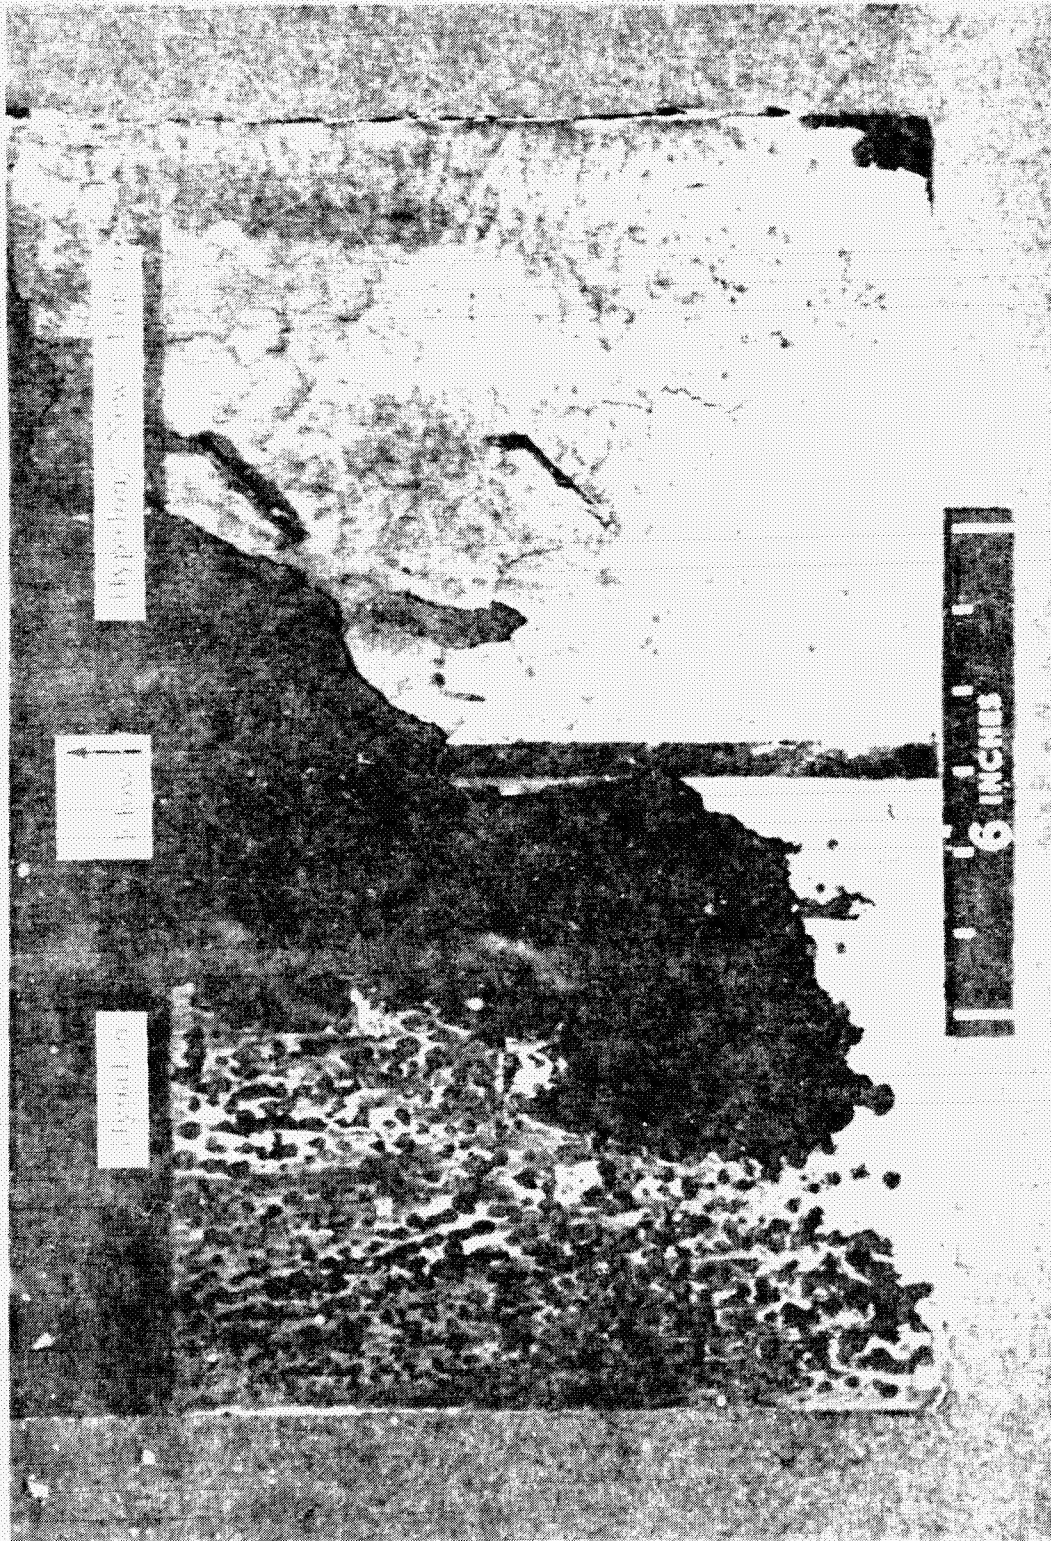
Fig. 7b - Post-Test Photograph Showing Evidence of "New" Turco Paint Flow After Overcoat of Hypalon Was Lost on One Side And Bubbling and "Popcorning" Behavior of Hypalon on MSA on the Other Side (Compare with Fig. 5b)

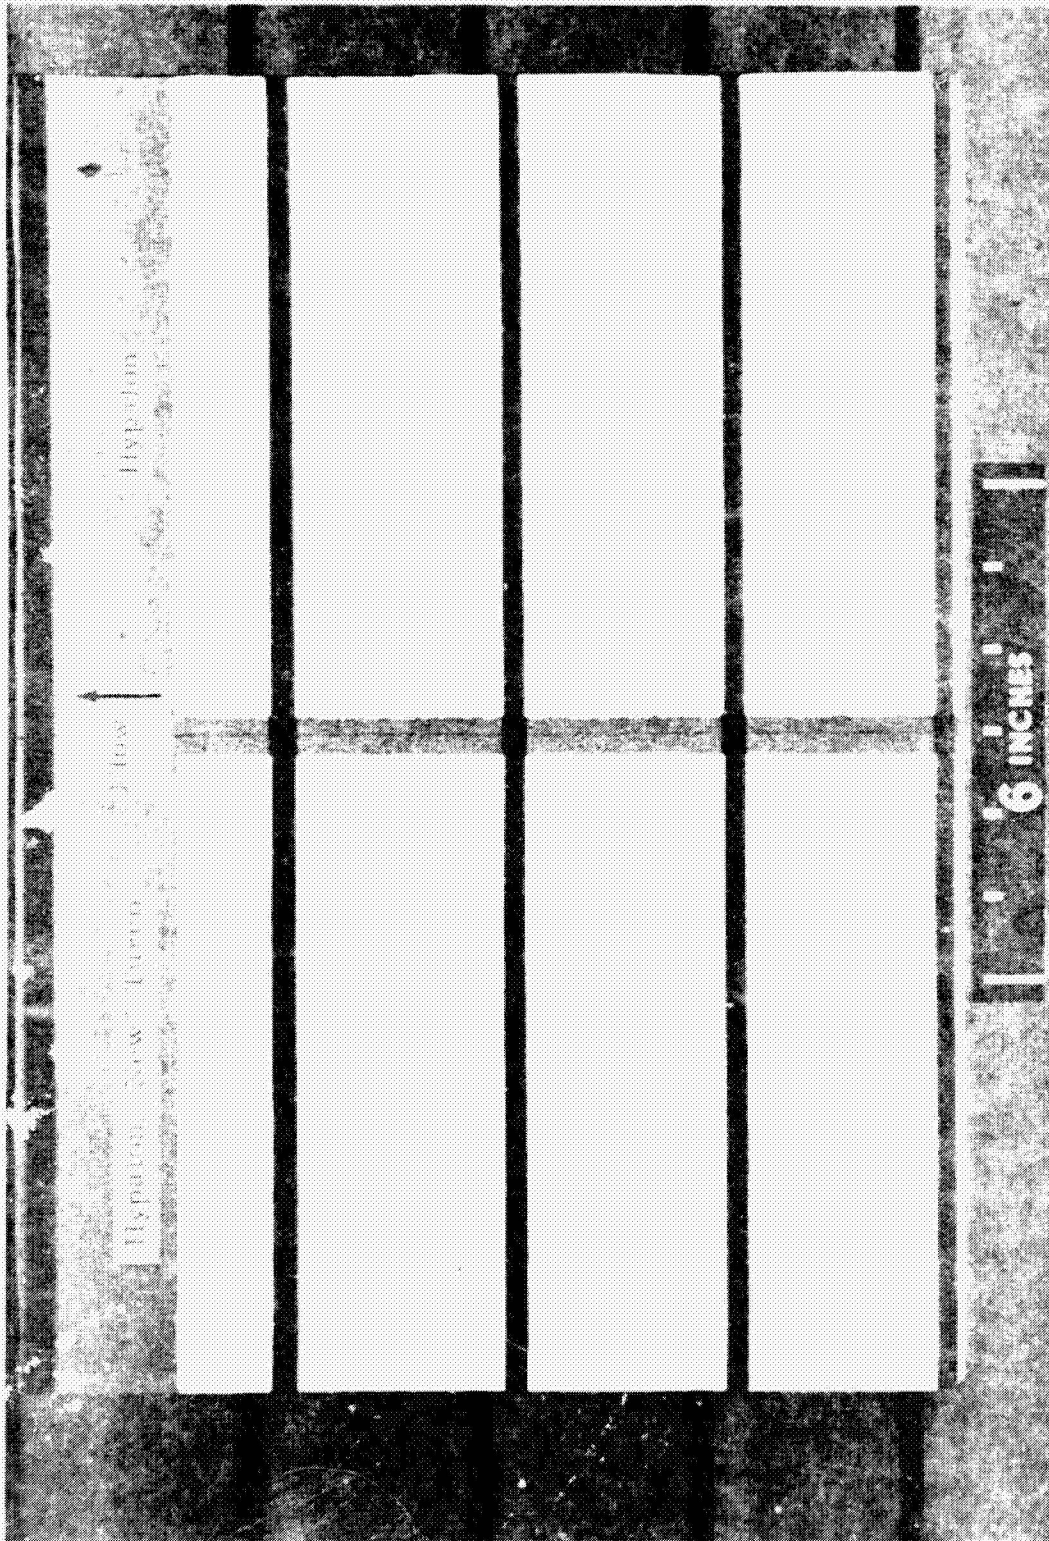
Fig. 8a - Pretest Photograph of Hypalon Paint and an Overcoat of the Same on "New" Turco
on P-50 Cork TPS (Panel C-6)

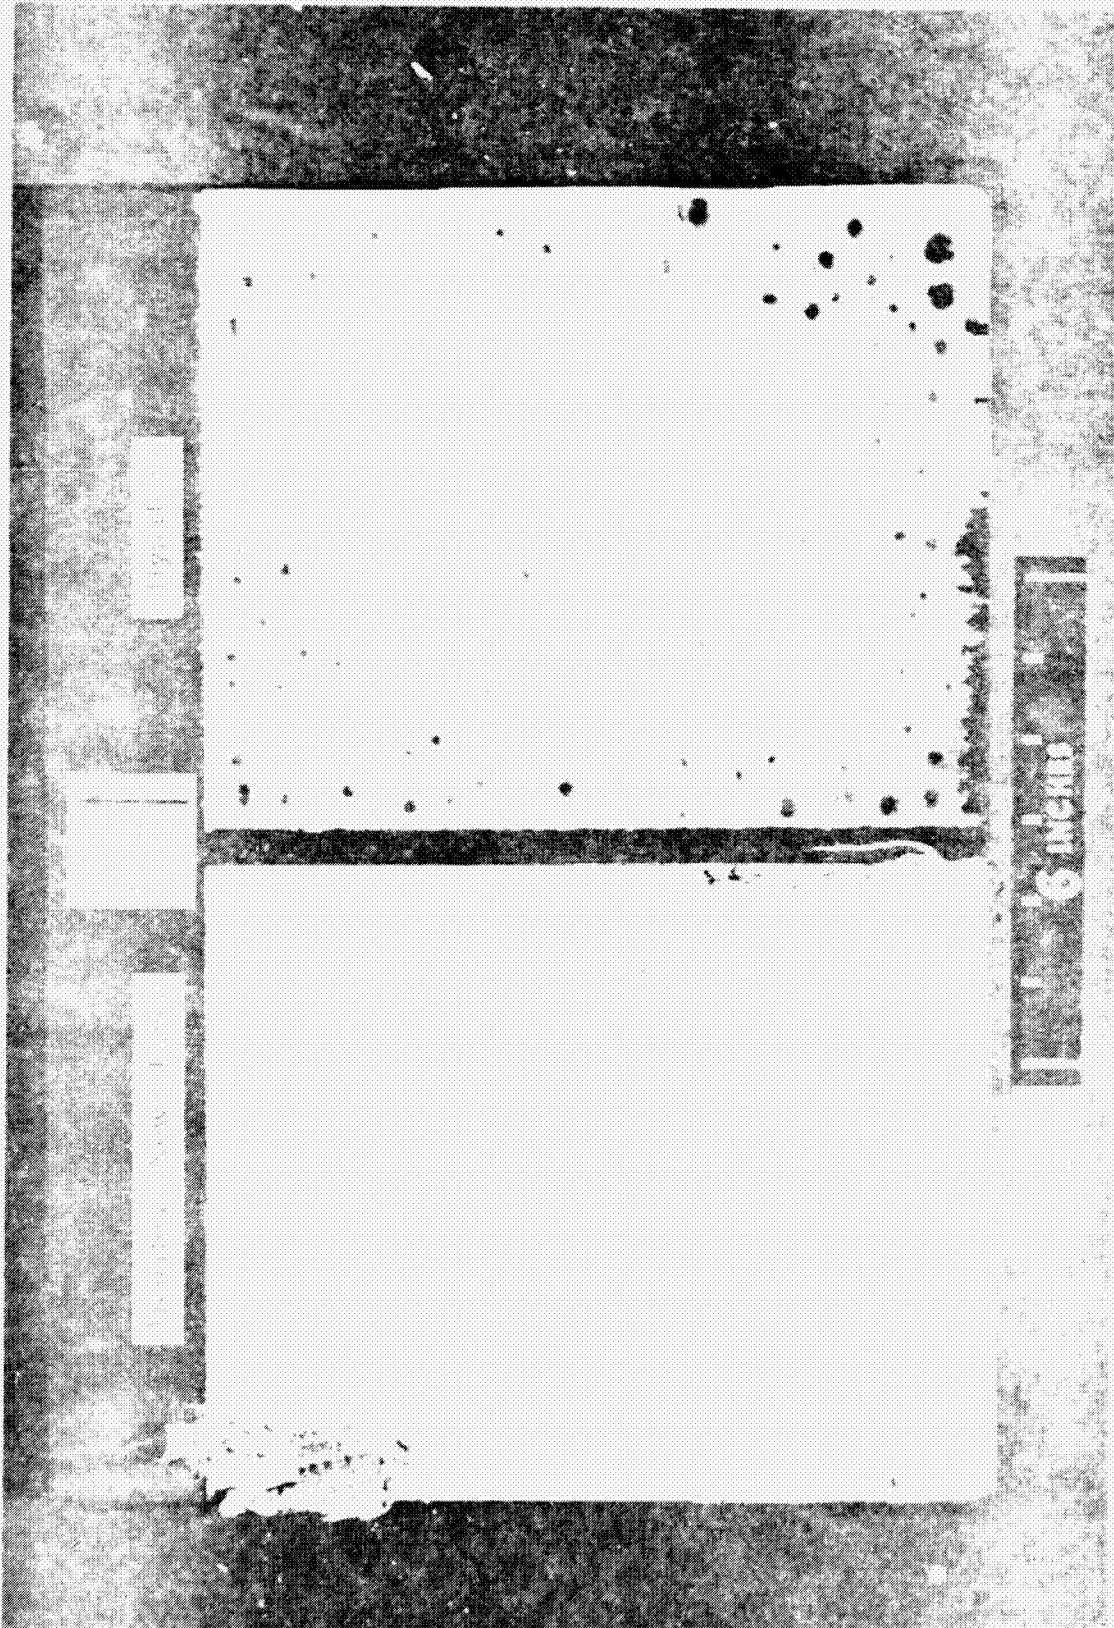
Fig. 8b - Post-Test Photograph of a Short Duration (37.3 sec) Run Showing the Performance of Hypalon on "New" Turco and Hypalon by Itself (Compare with Fig. 5b)

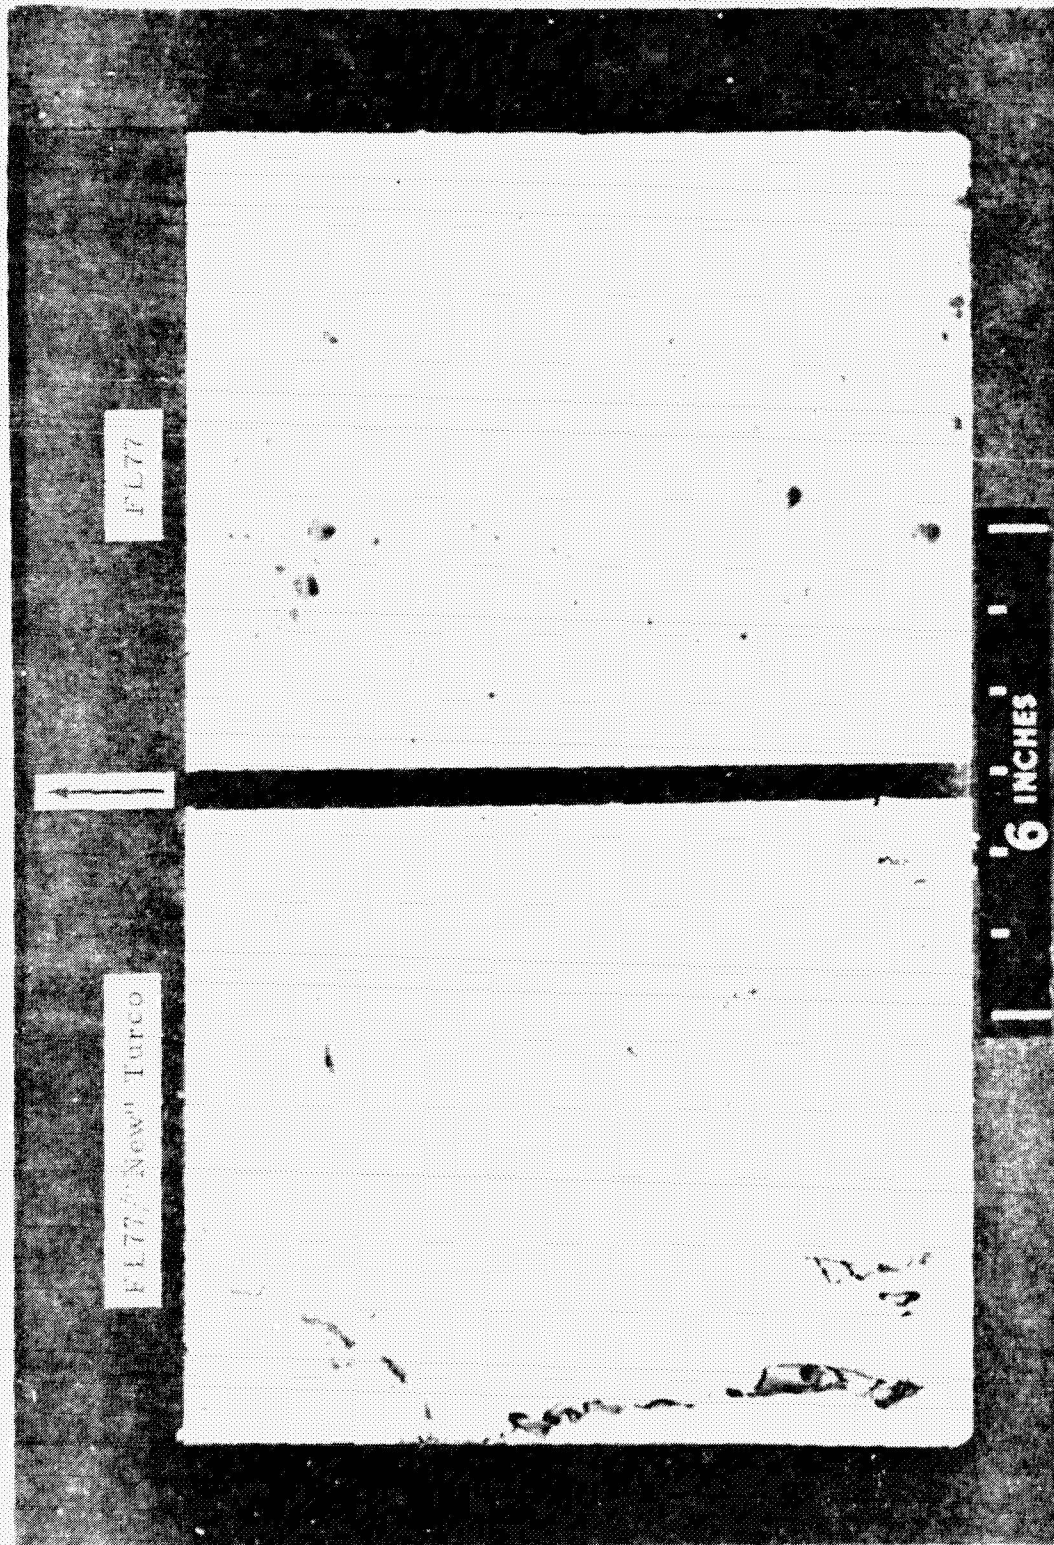
Fig. 9 - Post-Test Photograph of Paint Panel with FL77 Coating and FL77 over "New" Turco
Showing the Problem of Peeling of FL77 over the "New" Turco (Panel C-14)

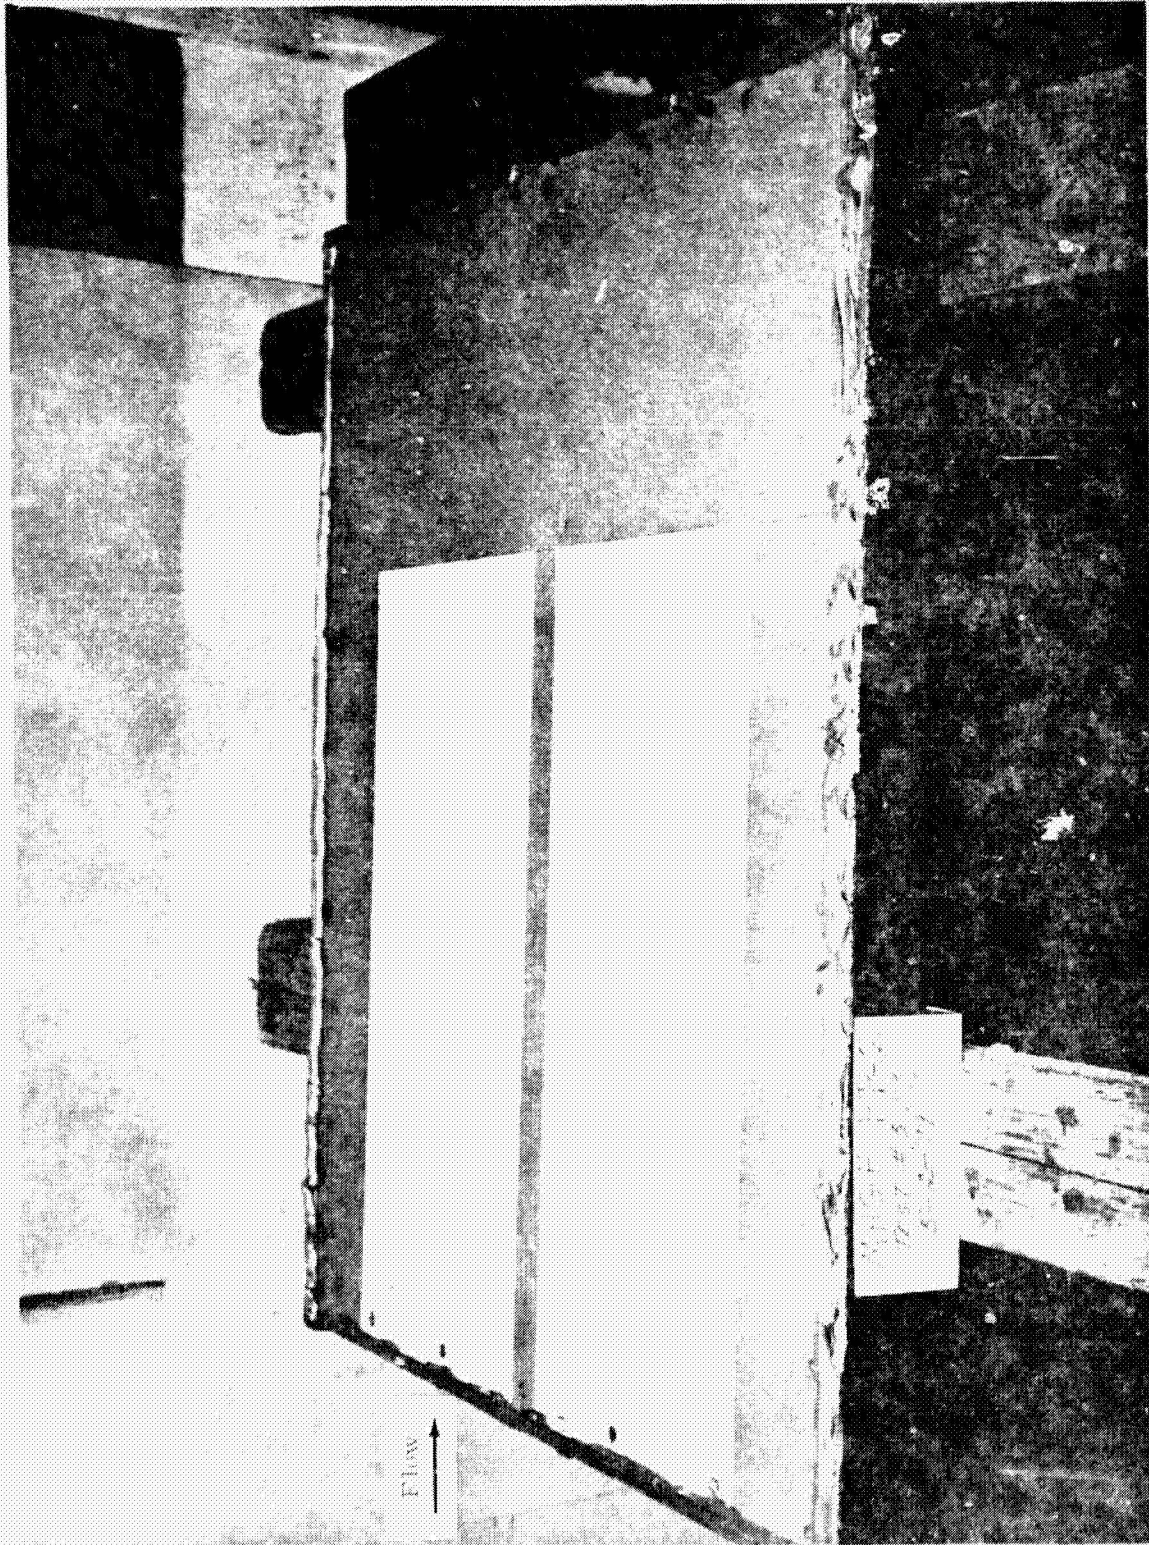
Fig. 10a - Pretest Photograph of Hot Gas Facility Paint Test Panel with Hypalon on P-50 Cork

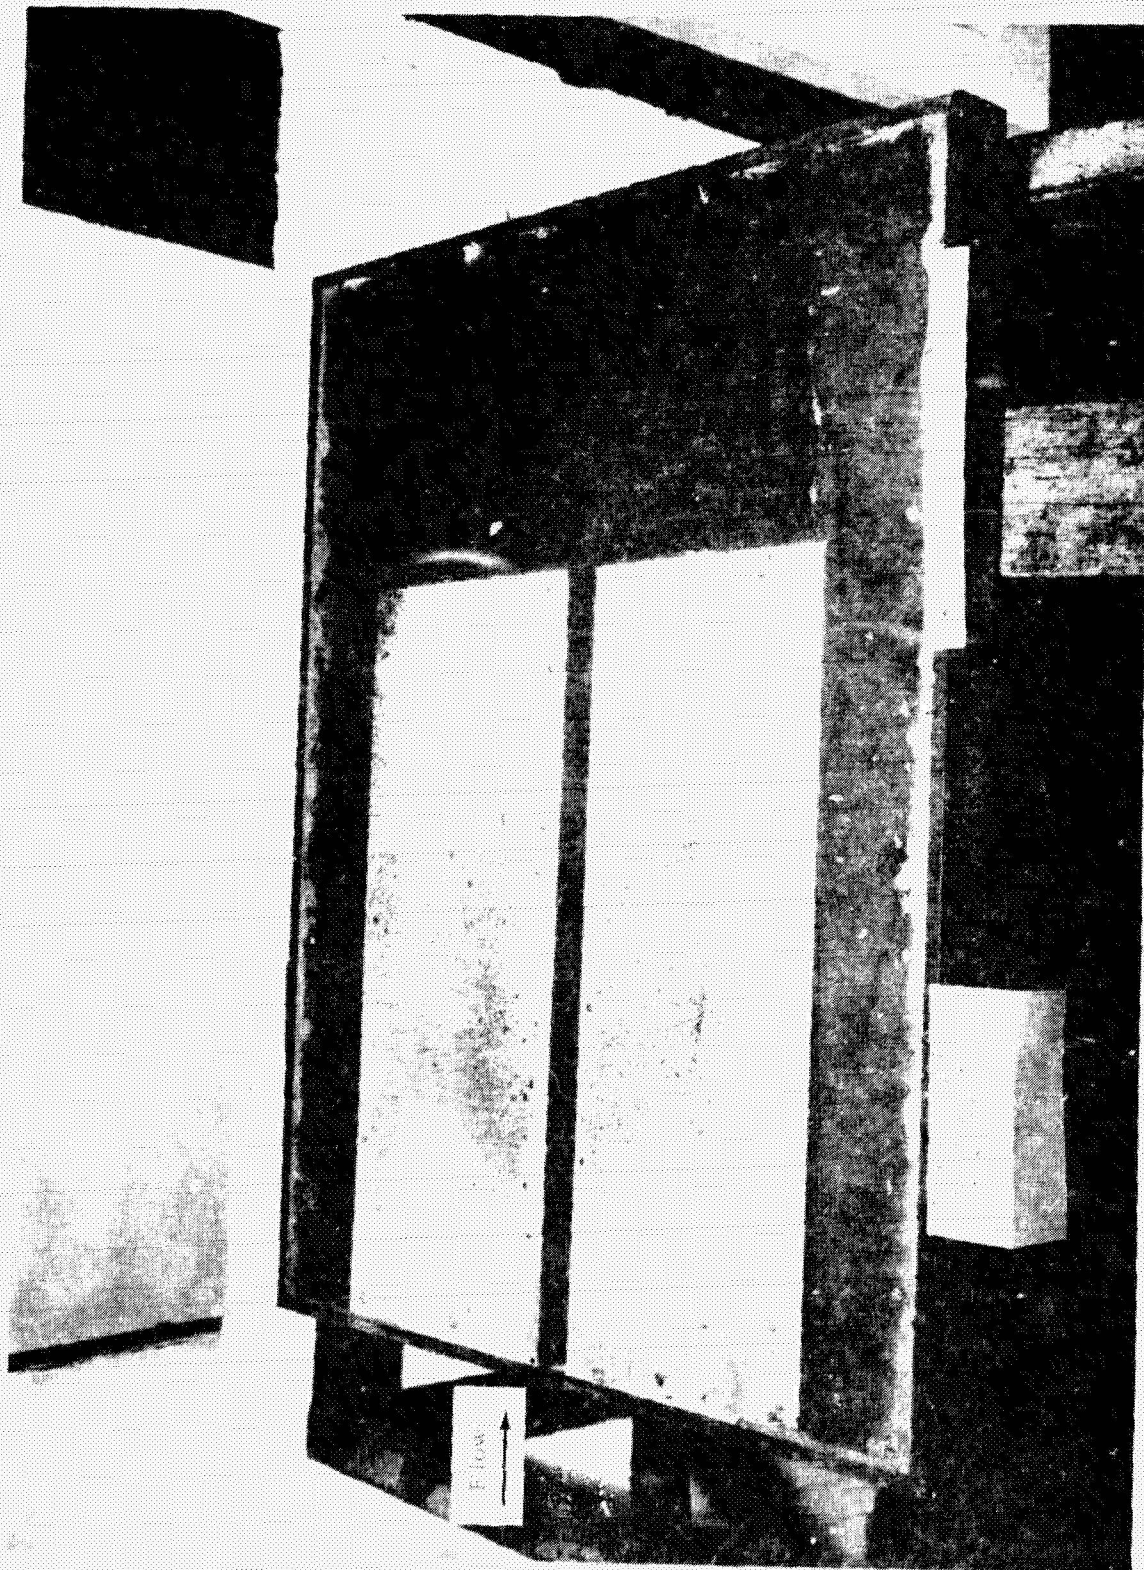
Fig. 10b - Post-Test Photograph of Hypalon Paint Panel Showing No Flow of the Paint
